Road Surface Patch Repairs

System overview

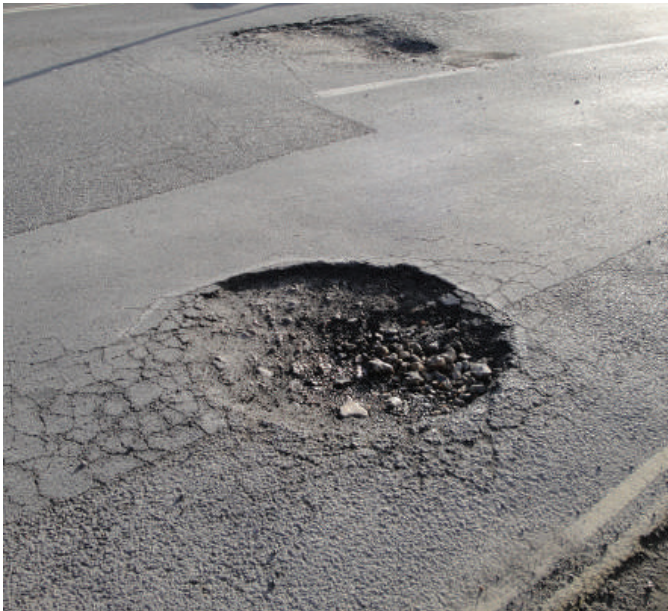
The material arrives on site ready mixed, and after removing the defective area by cold milling it is levelled into place. Traffic can pass over the area within just two hours, meaning not only less inconvenience for road users but lower highway maintenance costs.
