Meticulous Mastic Asphalt Refurbishment at Tower House

Mastic Asphalt Council (MAC)

a small but meticulously delivered mastic asphalt application on a Grade II listed building known as Tower House in Arundel, West Sussex.

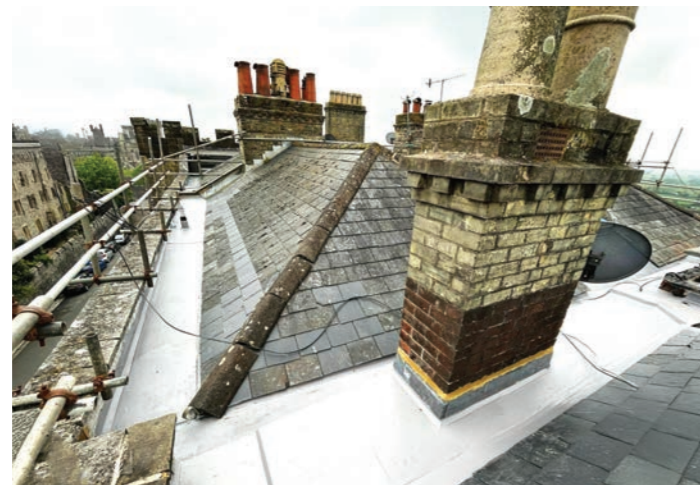
This project involved a significant amount of asphalt heritage detailing - in fact much more than the flat roofing area.

This project involved a significant amount of asphalt heritage detailing - in fact much more than the flat roofing area. Sussex Asphalte laid 27m² of horizontal asphalt and 51m² of asphalt detailing including skirting, fillet, sloped faces, collars, corners and solid asphalt drip edges.

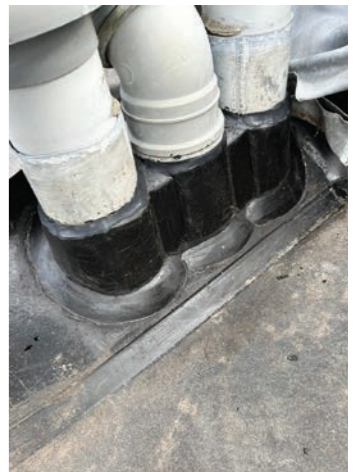
clearing the area so the roof area could be stripped and re-asphalted.

This needed to be implemented with military precision to ensure the area was covered with two coats of mastic asphalt, marrying in all the asphalt joints and solar painting, so that the tank could be reinstated the next day.

The extra complication to this was that some of the area underneath had a rotten deck, which needed to be removed and reboarded before any asphalt could be laid. The tank was re-positioned in the same location as before, but IKO Protectoboard were laid underneath to protect the asphalt from point loading.
